Maryland's BMPs for Timber Harvest Operations

Location: Frederick County, MD
Sugarloaf Mountain

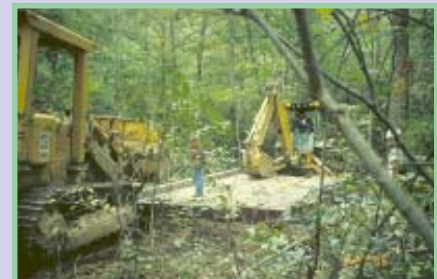
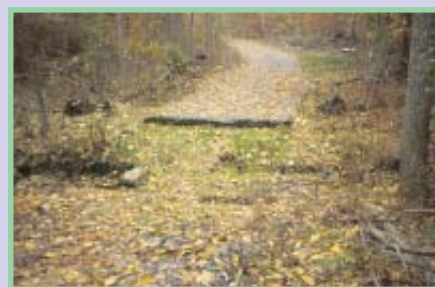
The portable bridge is removed post harvest and streambanks are stabilized by seeding.

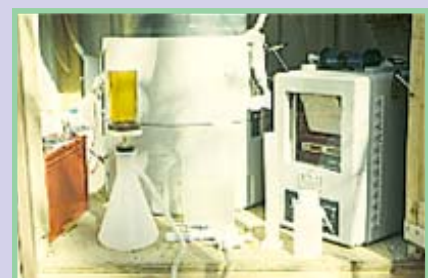
Scientific instrumentation used to monitor total suspended solids (TSS), flow, and temperature.

Monitoring stations were established on the lower reaches of both watersheds. Biweekly baseflow and storm water samples were collected at each station and analyzed for **total suspended solids**. Automated **temperature** meters were installed in both watersheds, and **benthic macroinvertebrate** samples were taken each spring and fall.
